TECHNICAL ASSISTANCE REPORT
EVALUATION OF DEER WARNING REFLECTORS IN VIRGINIA

B. H. Cottrell, Jr.
Senior Research Scientist

Virginia Transportation Research Council
(A Cooperative Organization Sponsored by the
Virginia Department of Transportation and
the University of Virginia)

June 2003
VTRC 03-TAR6

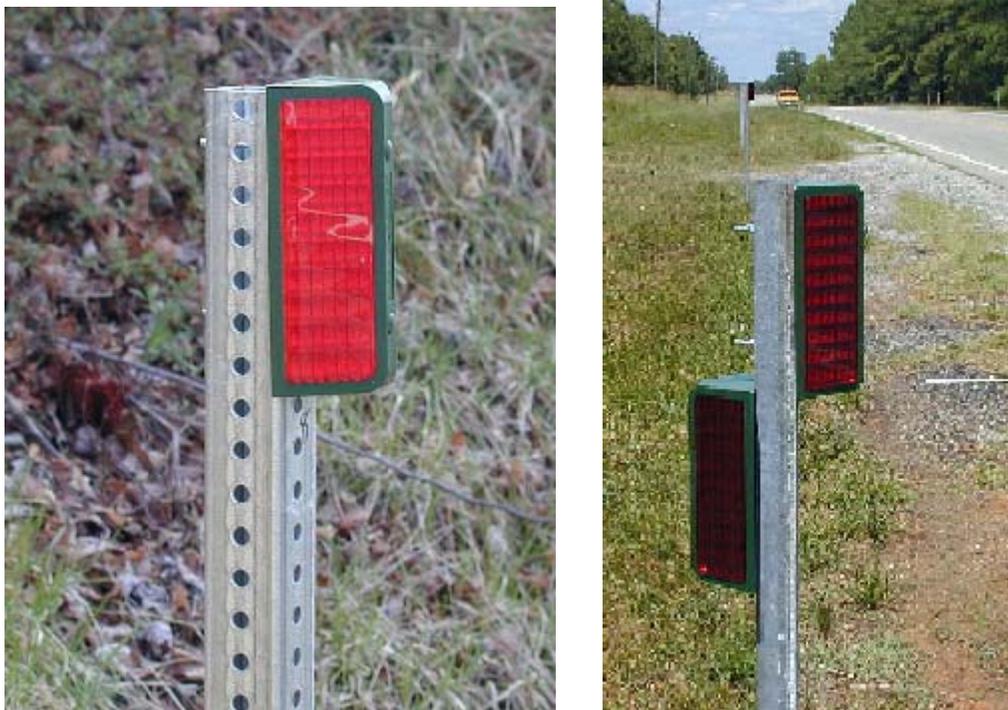
Figure 1. Standard and Alternating Back-to-Back Reflector Installations

The device consists of a red, double-sided reflector mounted on posts similar to those used for roadside delineation along roadways with horizontal curves (see Figure 1). The red reflector is 6.5 in long and 2 in wide. As vehicles approach and move through the road section, it is purported that the Strieter-Lite marker reflects the beam from vehicular headlights across the highway in a moving pattern of low-intensity red light beams, which in turn gets the deer's attention and deters them from entering the roadway. The shaded area across the roadway in Figure 2 denotes the coverage of reflectors facing the road. Although the light beams are not visible to the motorist, deer that see the unnatural and moving light pattern (referred to as a light fence) are expected not to cross the roadway while the light fence is present. To ensure

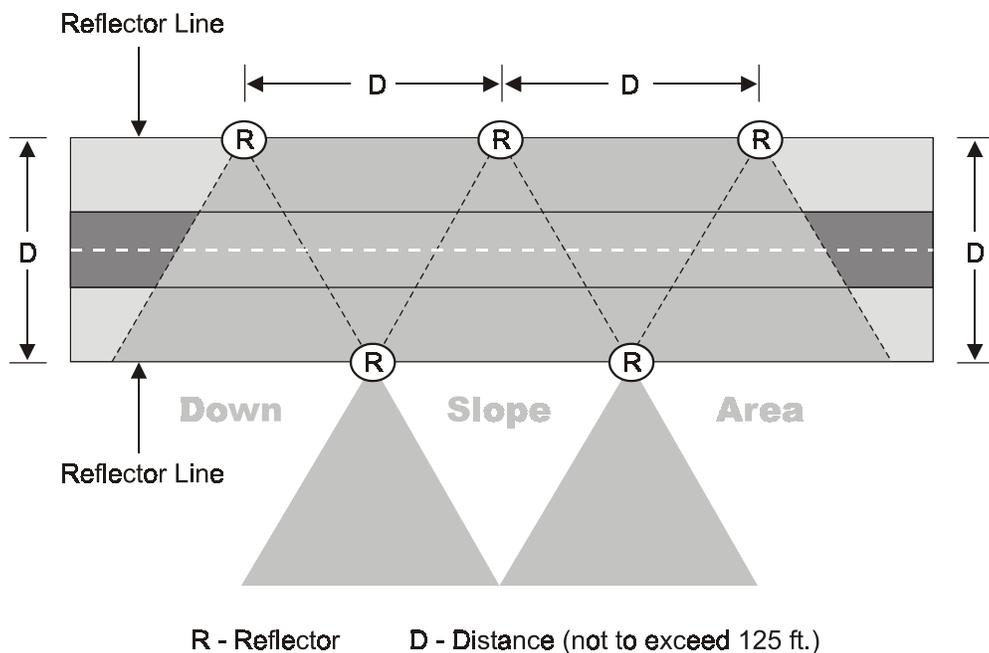
Figure 2. Reflector Coverage On-Road and Roadside with Elevation Changes²

the entire section of roadway identified as deer-accident prone is protected, markers are placed at a predetermined spacing based on the roadway alignment conditions. The reflectors are mounted at a height of 24 to 30 in. When there is a change in elevation that prevents deer on the roadside from seeing the dim light forming a moving pattern across the road, reflectors are placed on the back side of the post facing the roadside. A light pattern is also displayed off the road, as shown in the down slope area of Figure 2.

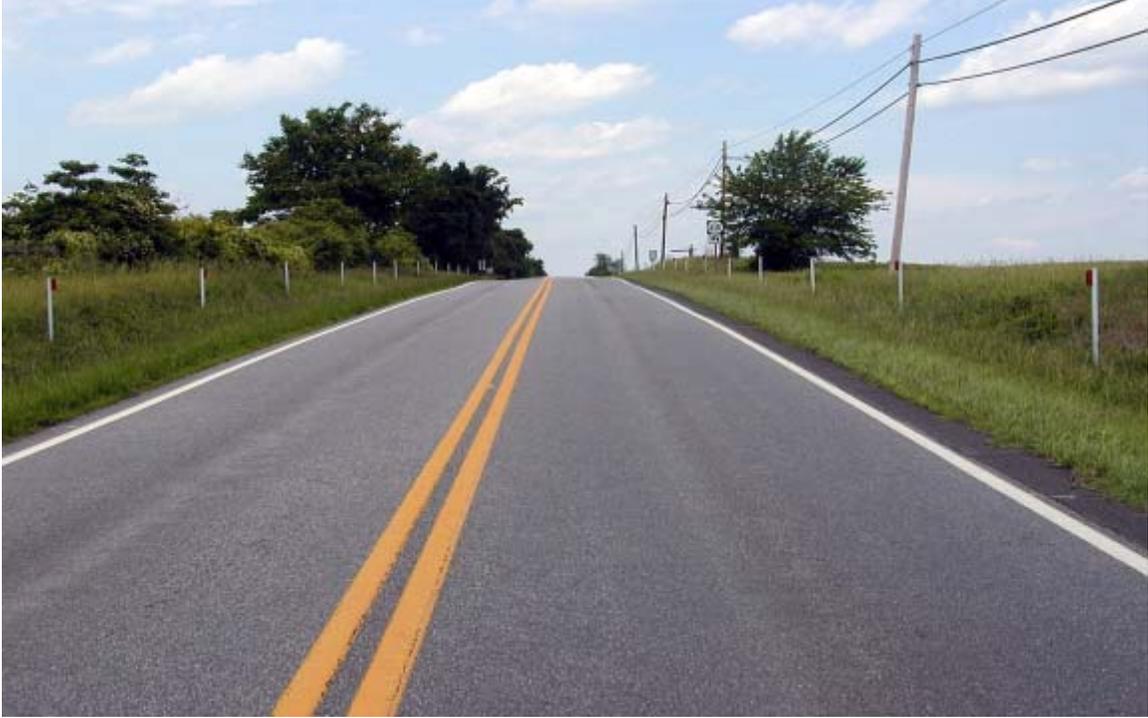
Figure 3. Deer Warning Reflectors on Route 15 in Madison County

Figures 3 through 5 display road sections of three sites where deer warning reflectors were installed.

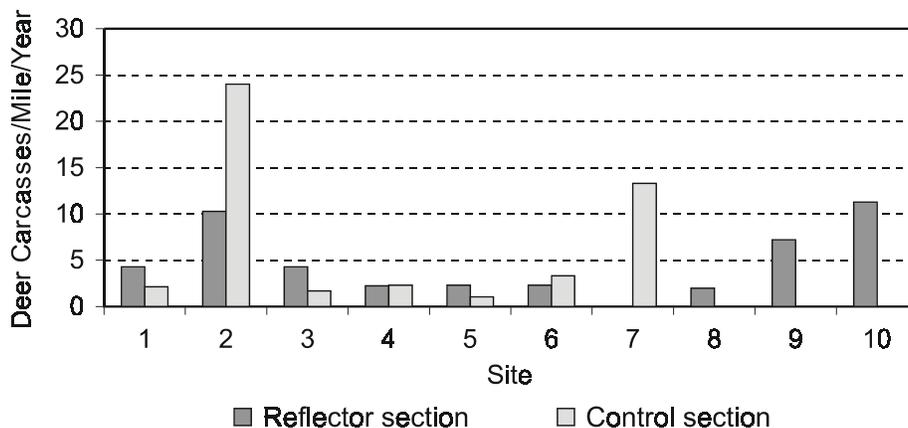
Figure 6. Deer Carcass Pickups for Reflector and Control Sections of Study Sites

Figure 6 displays the difference in the number of deer carcass pickups between the reflector and control sections. The number in the control section for sites 2 and 7 stands out. At sites 1 and 3 through 6, the carcass pickup differences were minor. The absence of deer carcass pickups in reflector sections at sites 8 through 10 is also evident.
